Connector Crack Analysis Elimination Of Crack In Connector Manufacturing Process

They have some problems in production in their connector production line some of the parts having surface crack in connector neck surface area, due to this they doing 100% of crack detection (MPI) both in process and final inspection, due to this their productivity affected and not able to meet the customer target quantities .To solve this issues we analysis the each process and which process and what parameters create the crack in connector neck area

The main objective is to study the connector manufacturing process and identify the factors and parameters to create the crack in the connector neck area and solve the issues in systematic problem solving approach and produce the crack free parts..

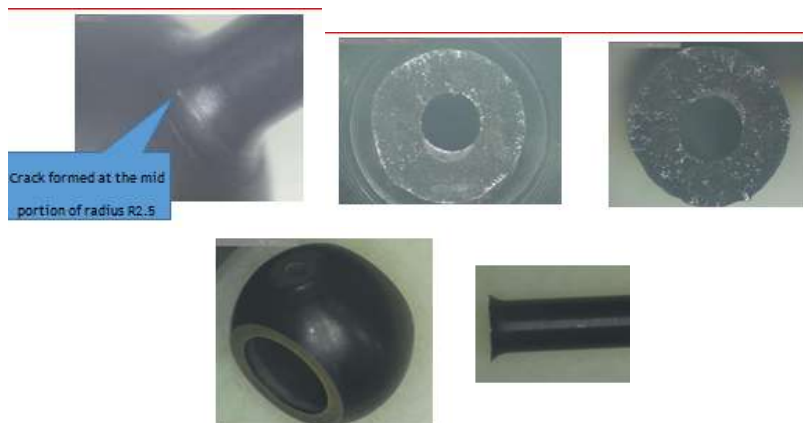
Defect part analysed both dimensionally and visually found below observations,

- Crack formed at the mid portion of radius R2.
- No other damages observed
- Blackening happened the cracked area, hence crack was generated before blackening operation

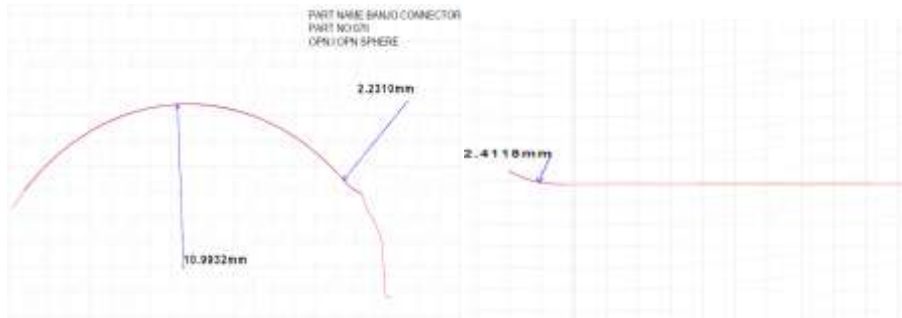
- No dimensional deviation found
- Profile formation and roughness are found normal

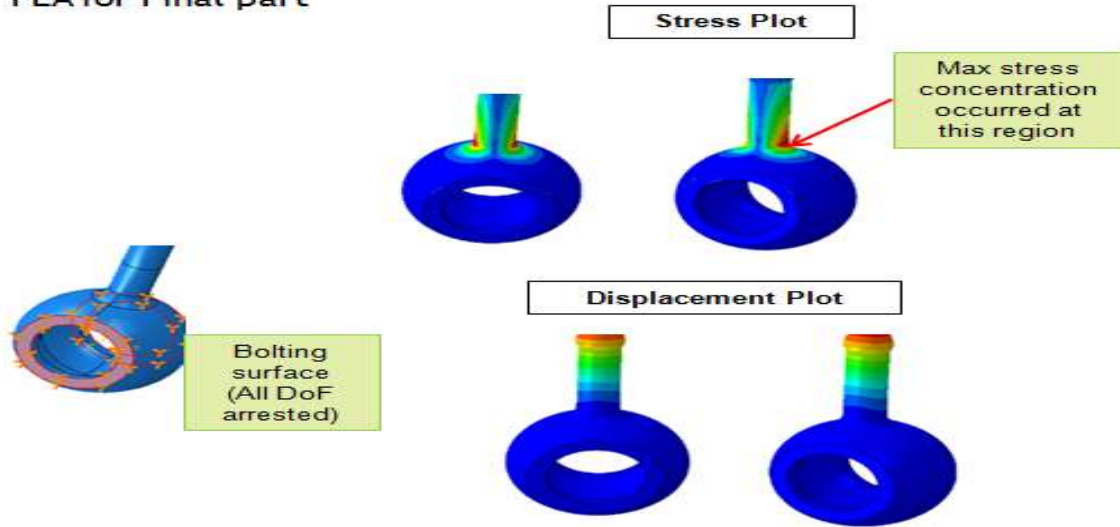
FEA for Final part

The R2.5 is the potential area tends to prone for crack since the cross-section area is very less in CNC 2nd operation.

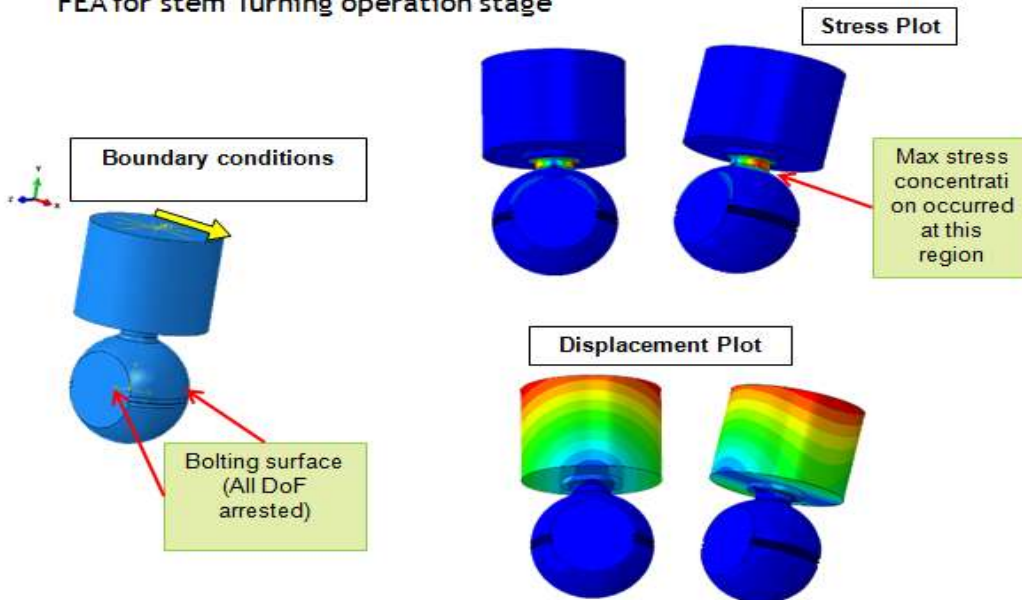
FEA for stem Turning operation stage

So during CNC operation due to the high stress in radius 2.5 area crack generation will be happen.

- Cross sectional area will be increased from 6mm to 20 mm by forming half radius of R22 Spear in CNC 1st operation and another half in CNC 2nd Operation
- MPI Test will be conducted after blackening process to improve the visibility because of black in nature

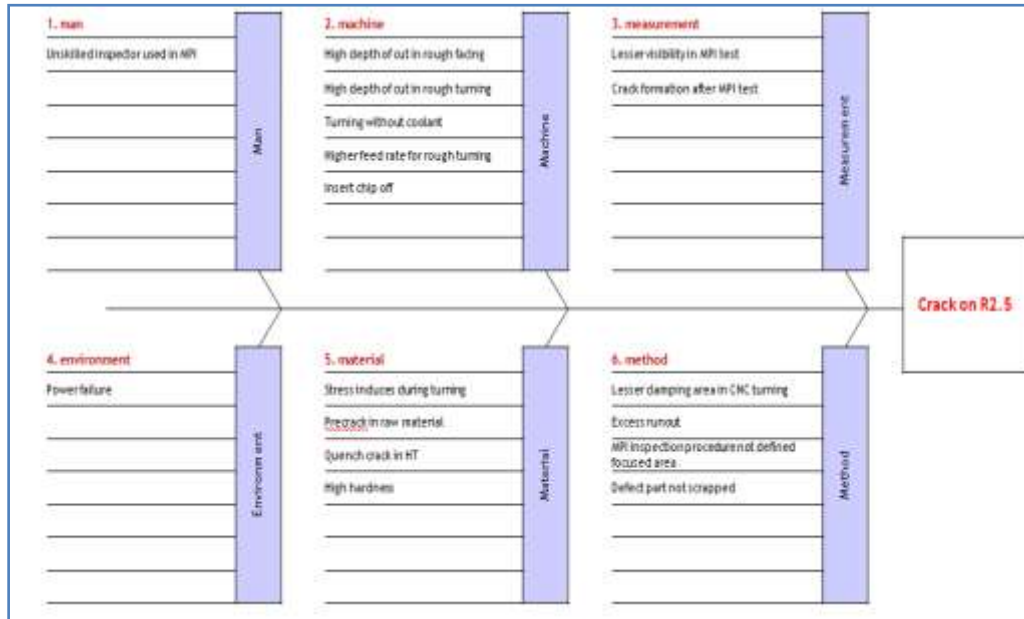
No.	Ishikawa Category	Ishikawa Cause Item (Possible Cause)	Description	Relevancy for consideration (adequate for further root cause analysis, or to be excluded from analysis)	Reason for excluding
1	Man	Excluded Cause	Unskilled inspector used in MPI	excluded	Level 2 certified inspectors used for MPI.
2	Machine	Excluded Cause	High depth of cut in rough facing	excluded	In simulation trials, no crack formed, but insert got
		Excluded Cause	High depth of cut in rough turning	excluded	In simulation trials, no crack formed
		Excluded Cause	Turning without coolant	excluded	In simulation trials, no crack formed
		Excluded Cause	Higher feed rate for rough turning	excluded	In simulation trials, no crack formed
		Excluded Cause	Insert chip off	excluded	In simulation trials, no crack formed
3	Measurement	Possible cause	Lesser visibility in MPI test	Relevant	Visibility is more for MPI after blackening process than before

Excluded Cause	Crack formation after MPI test	excluded	Blackening happened inside crack
4	Environment	Excluded Cause	Power failure	excluded	Machines are connected with UPS
5	Material	Possible cause	Stress induces during turning leads crack	Relevant	FEA shows stress induced at lesser C/S at R2.5 in CNC 2"
		Excluded Cause	Pre-crack in raw material	excluded	No abnormality found in microstructure analysis
		Excluded Cause	Quench crack in HT	excluded	No abnormality found in microstructure analysis
		Excluded Cause	High hardness	excluded	Hardness found within specification
6	Method	Excluded Cause	Lesser damping area in CNC turning	excluded	In simulation trials, no crack formed
		Excluded Cause	Excess runout	excluded	In simulation trials, no crack formed
		Excluded Cause	MPI procedure not defined focused area	excluded	Verified procedure found OK

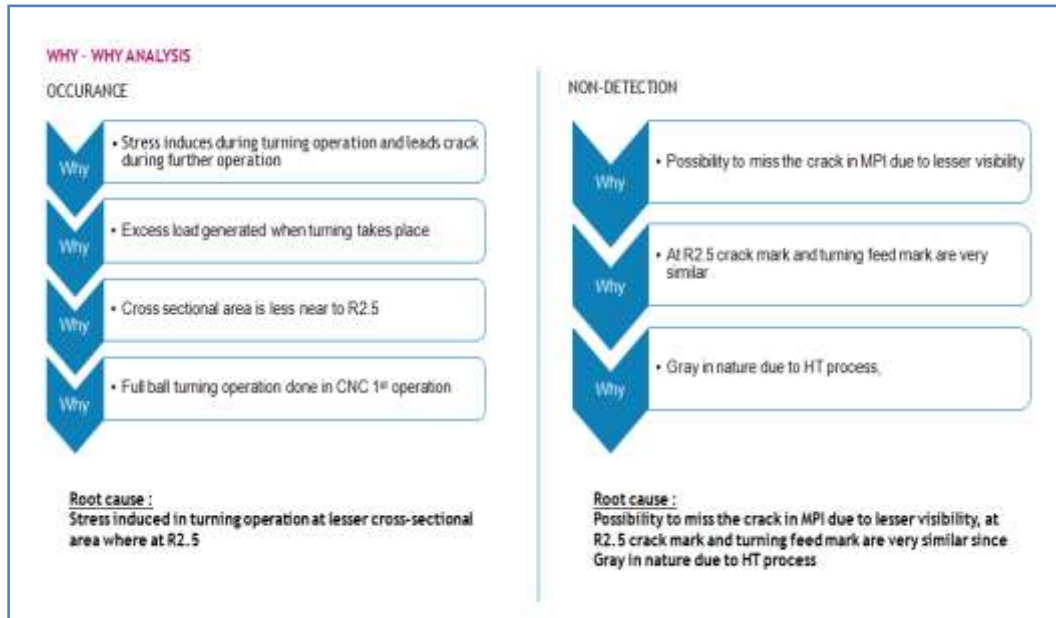
Analysis done for occurrence and Non detection of Defective parts due to stress induced in lesser cross sectional area the crack initiation and

after HT process the part colour change to gray and crack marks and turning feed line very similar so missing possibility in MPI (Magnetic particle inspection)
