# Repair of Spillway and Energy Dissipater Severely Damaged By Rolling Boulders during Floods in Himalaya

This hydroelectric scheme was planned to harness the energy of waters flowing down in a Himalayan River. The project was commissioned in the early nineteen eighties. The annual generation of this project is approximately 455 MU.

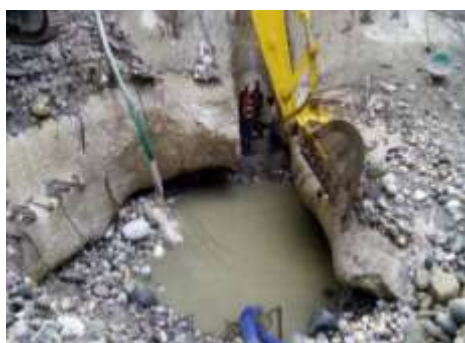
Photograph 3: Cavity in Slotted Roller Bucket

Three deep scour holes /pits of big size had formed in the bucket area in front of bays 1, 2 & 3. One of the pits in front of bay-3 was the deepest. These pits were reported to be interconnected. For filling these holes /pits, the following was recommended:

- First select the scour hole / pit with the least depth for repairs, out of the three.
- After dewatering, chipping of the entire concrete surface of the hole /pit to get a rough surface, is to be carried out.
- After cleaning and drying of the pit and provision of dowel bars, fill the pit with M20 concrete with non-shrink admixture by tremie concrete in lifts of 1 m height and giving a time gap of minimum 72 hours between each lift.
- Provide reinforcement mesh of 20 mm dia. Tor steel bars @ 150 mm c/c both ways in the top layer and flush it with the existing surface. This area is later to be covered with high strength concrete as required for the EDA.
- Consolidation grouting of the area in the bucket portion to close any inter connections of pits and damaged rock mass with open joints etc.

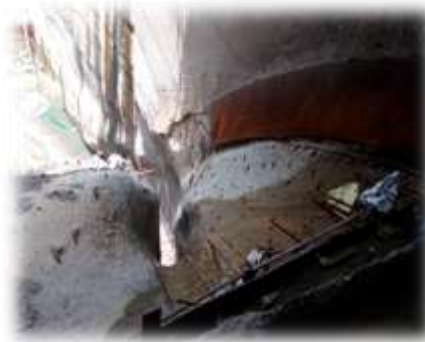
The damages observed in spillway bays no. 1 on the right bank (Photograph 2) were mainly as under:-

- a) The sill beam of stop log gate and radial gate was washed out in a length of approximately 6.00 m and 8.00 m respectively out of a total length of 13 m. The flange of the remaining sill beams was also completely damaged.
- b) As both the sill beams were washed out in some length, therefore a cavity of about 6 to 7 m in length along the piers having a depth up

to 2.00 m was created in between the radial gate and stop log gate. The flood also damaged the spillway glacis on the right side and in the d/s of radial gate sill beam throughout its length & up to the slotted roller bucket in about 3.00 m width with varying depth with a maximum 13.00 m depth.

Photograph 2: Damages in Spillway Bay no 1

- a) Repair work from the sill beam of stop log gates to 2.00 m downstream of sill beam of radial gates by taking shutdown of powerhouse for a period of around a month.
- b) Repair work in entire spillway glacis from 2.00 m downstream of sill beam of radial gate in running powerhouse condition.

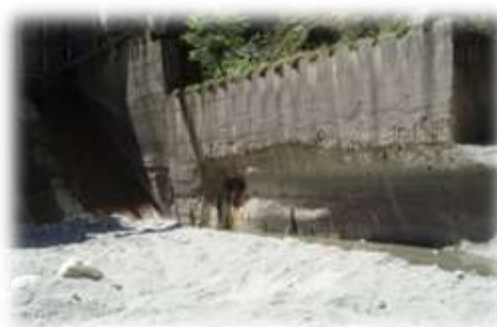
- a) The concrete in between the stoplog gate and the radial gate was eroded due to high flood. The depth of erosion was in the range of 0.25 m to 0.70 m.
- b) The spillway glacis was also damaged. The depth of erosion ranged from 0.25 m to 0.80 m.
- c) The damages in the energy dissipation arrangement and the downstream areas were mainly as under:
  - The slotted roller bucket was completely damaged and was washed out (See photograph 3).
  - Deep scour holes/cavities were observed in the bucket area.
  - The spillway training walls were badly damaged – the damage being much more in the right training wall (See photograph 4).

Photograph 4 Damaged Training wall

The training walls were originally constructed with a converging alignment in plan. In addition to the slotted roller bucket which was totally damaged the training walls were also badly damaged in the flood as can be seen in photograph 4. To improve the flow conditions and to mitigate the damages due to flowing boulders, these walls were dismantled and re-constructed with a straight alignment.

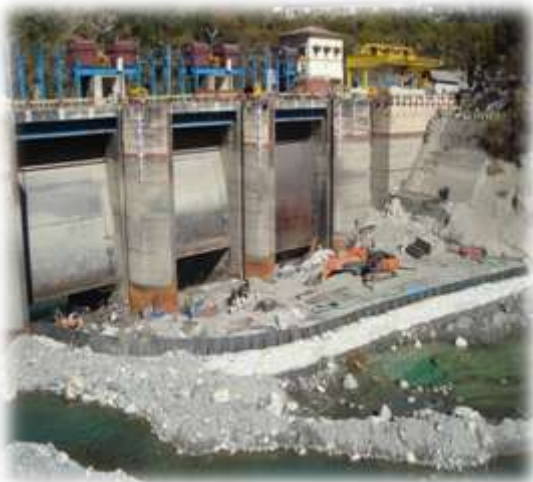
Photograph 5: (Temporary Bund for channelization of stream water)

- a) Creation of bund in front of spillway bay 1, 2 & 3 to divert water through spillway no. 4 (see photograph – 5).
- b) Dismantling damaged mild steel sheets previously placed over spillway concrete profile.

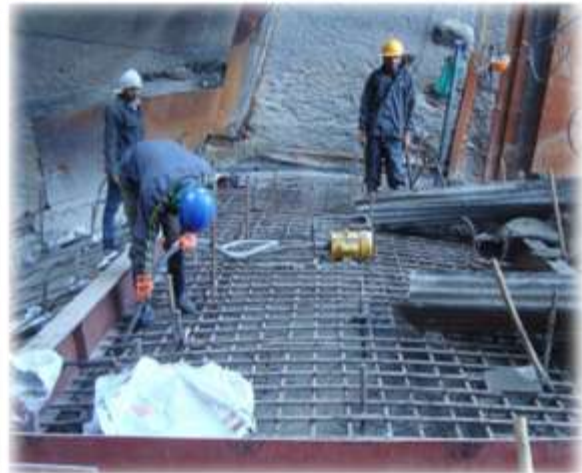
Photograph 6: (Laying concrete in spillway bay no 2)

- h) Applying bonding coat between old and new concrete.
- i) Laying of concrete (Dry Crete of M80 grade) in the cavity between sill beam of stop log gate and radial gate (see photograph – 6 & 7).

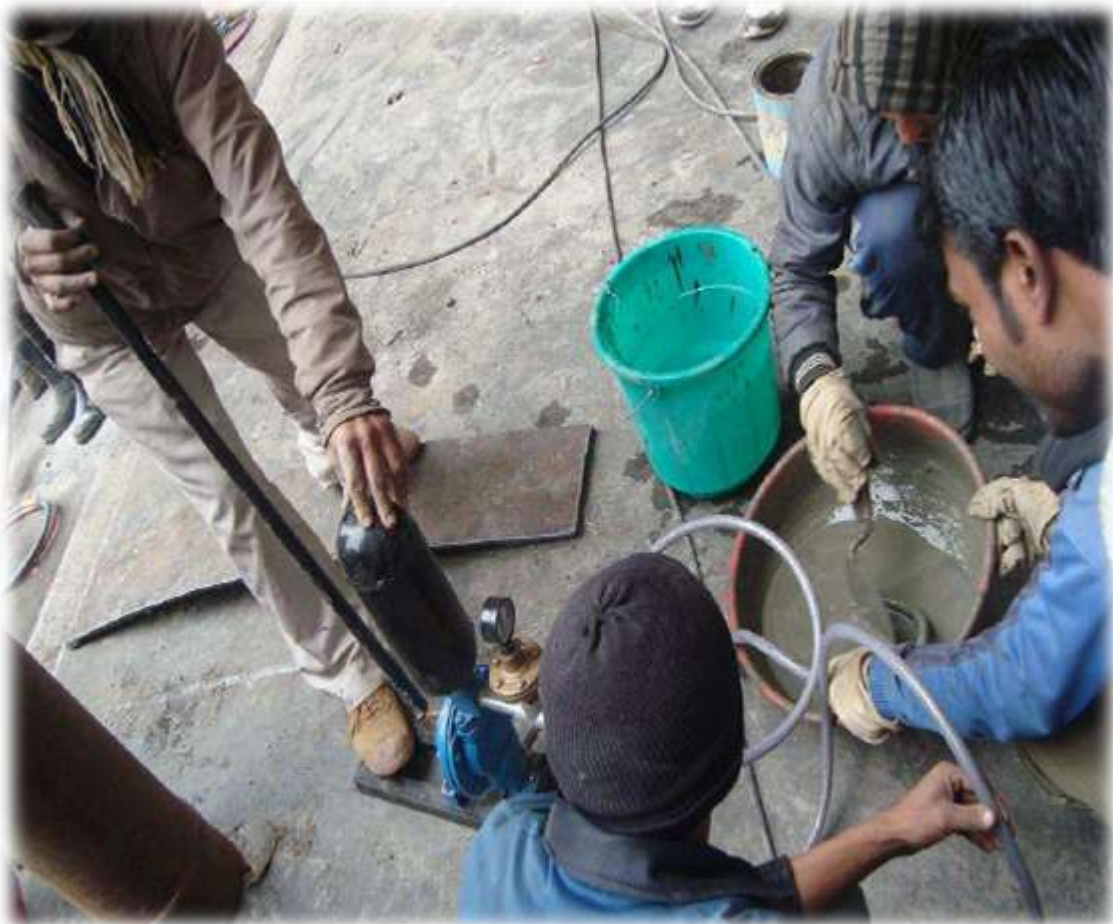
Photograph 7: Laying and Grouting of MS Plate in Spillway Bay no 2

- l) Fixing MS sheet (20 mm thick with a yield strength of 450 MPa) over the prepared concrete surface.
- m) Grouting between steel plate and concrete through holes cut in the steel plate.
