Geophysical Investigation of Road Pavement Instability: A Case Study of Moshood Abiola Polytechnic (Mapoly) – Onikolobo Road, South Western Nigeria

ABSTRACT

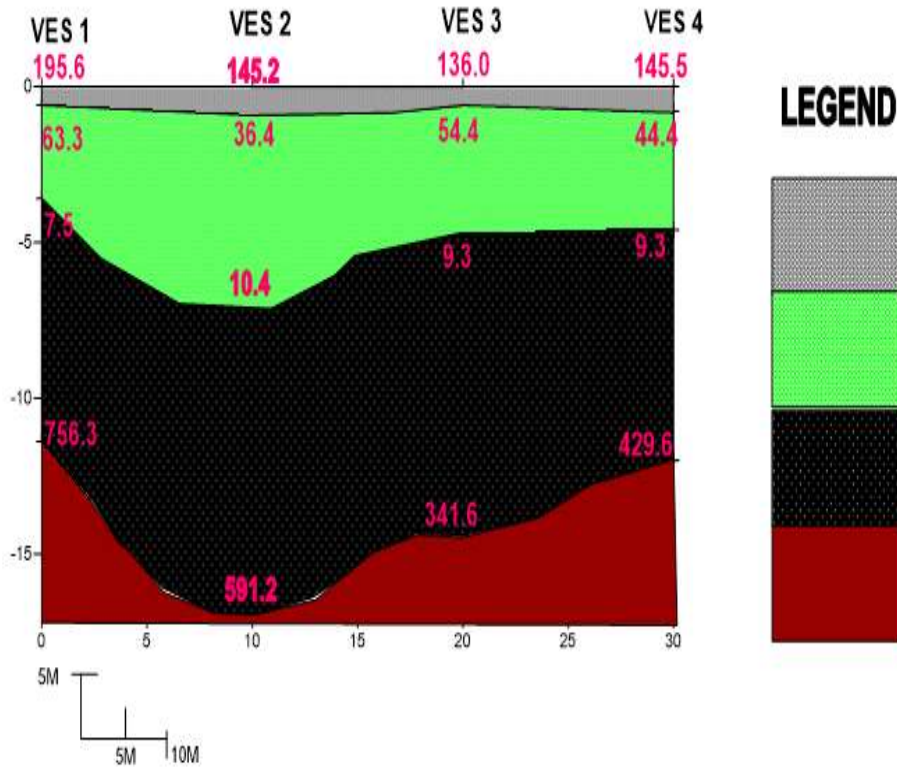
Fig 9: Geo-electric section showing resistivity values of VES1 TO VES4 traverse along Ojere village area

Fig. 9 represents the geoelectric section obtained from the VES along Ojere village area of the road. This geo-electric section shows the spatial

distribution of each layer of the subsurface.. The section shows four distinct layers which include the top soil, the lateritic soil, the weathered basement and the fracture basement respectively from top to bottom. The topsoil comprises sand/lateritic sand whose resistivity ranges from 136.0 Ωm to 196.6 Ωm, the thickness of this layer varies along the traverse and less than 1 m, it is thickest at VES 2, about 0.9 m. the average thickness along this layer is 0.75 m. The second layer is the lateritic medium to silty grained sandstone having a resistivity range of 36.4 to 63.3 Ωm with an average thickness of 4.25 m, it is thickest at VES 2 with a thickness of 6.2 m. Weathered basement is the third layer with resistivity range of 7.5 to 16.4 Ωm. The third layer,

the weathered basement has a resistivity range of 7.5 to 10.4 Ωm . This low value of resistivity as a result of highly weathered disaggregated minerals which are essentially clay. The fourth layer being the fresh fractured basement has a resistivity range of 341.6 to 756.3 Ωm . The overburden is thickest at VES 2 and a gentle depression is noticed at VES 2. The portion of the road, Ojere village, area where these VES 1 to VES 4 lies is in a serious failed state and this is due to clay composition of the underlying layers of low resistivity values which is characteristics of clay minerals. The basement depression under VES 2 might also have contributed to the failed state of this portion of the road.

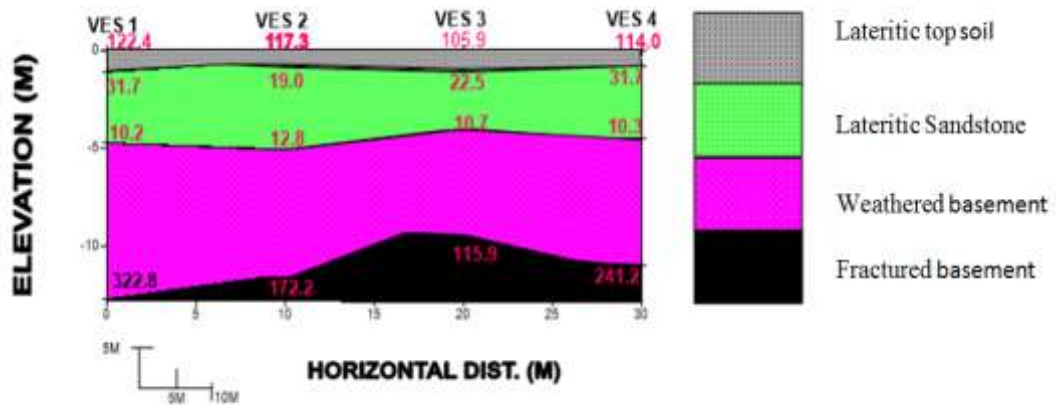
Fig 10: Geo-electric section showing resistivity values of VES1 TO VES4 traverse along Bank area

Fig. 10 represents the geo-electric section of the stretch of the road beside the microfinance bank within the study area. There are four layers within the subsurface in this area. The first layer with resistivity range of 104.0 - 122.4 Ωm (average value of 114.9 Ωm) is the lateritic topsoil with an average thickness of 0.93 m. The second layer, the lateritic sandstone has a resistivity range of 10.0 - 22.5 Ωm . Occupying the third layer is the weathered basement with a much lower average resistivity value of 11.0 Ωm , this low resistivity value may be accounted for by the presence of clay mineral which are the end product of weathering of migmatite and gneiss. The fourth layer is the fractured basement with a resistivity range of 115.9 - 241.2 Ωm (an average value of 213 Ωm). The low resistivity values of these layers within the subsurface of this traverse is an indication of clay composition which is capable of causing road instability. The relative stability of this stretch of the road may not be unconnected with the lateritic topsoil with relatively higher resistivity, regular maintenance and good drainage.

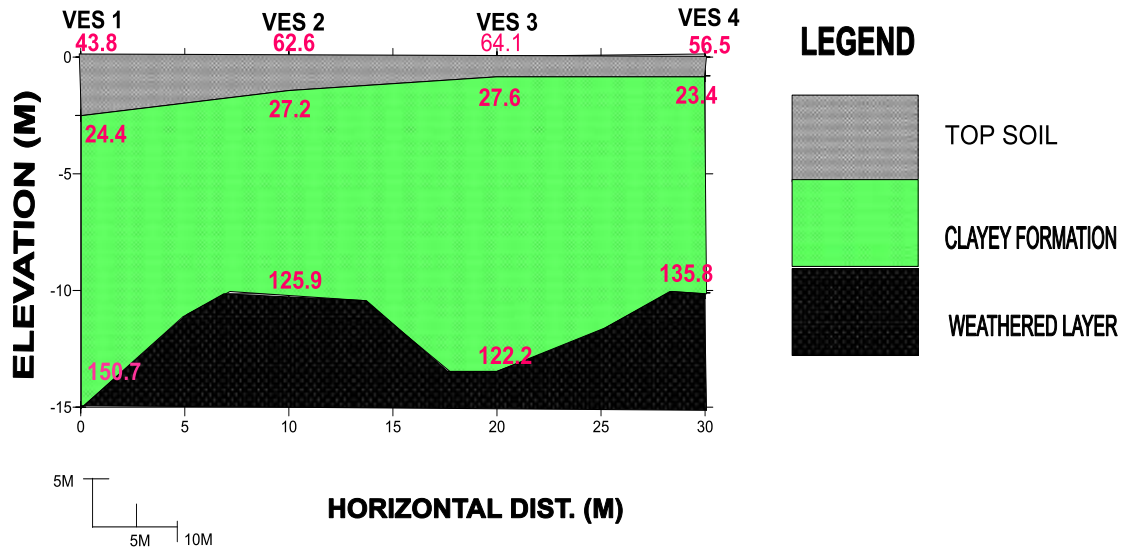
Fig 11: Geo-electric section showing resistivity values of VES1 TO VES4 traverse along Gate area

Fig. 11 is the geo-electric section of the stretch of the road close to the school gate. Three layers have been delineated in this area. They are the topsoil, clayey formation and weathered layer. The topsoil has its resistivity varying from 43.8 - 62.6 Ωm with thick overburden that is thickest at VES1. This topsoil is composed of clayey sand, sand and lateritic sand owing to its resistivity value. The second layer is clayey formation with characteristic resistivity range of 23.4 - 27.6 Ωm . The third layer is weathered basement with resistivity range of 122.2 - 150.7 Ωm and having basement depression at VES 3. Obviously all the layers within the subsurface of this section of the road are characterized with large clay content owing to their low resistivity values. The section of the road which falls in this area is stable despite this indication of clay content and basement

depression within its subsurface layer. This stability, also, may be as a result of regular maintenance carried out on it and presence of good drainage on its sides.

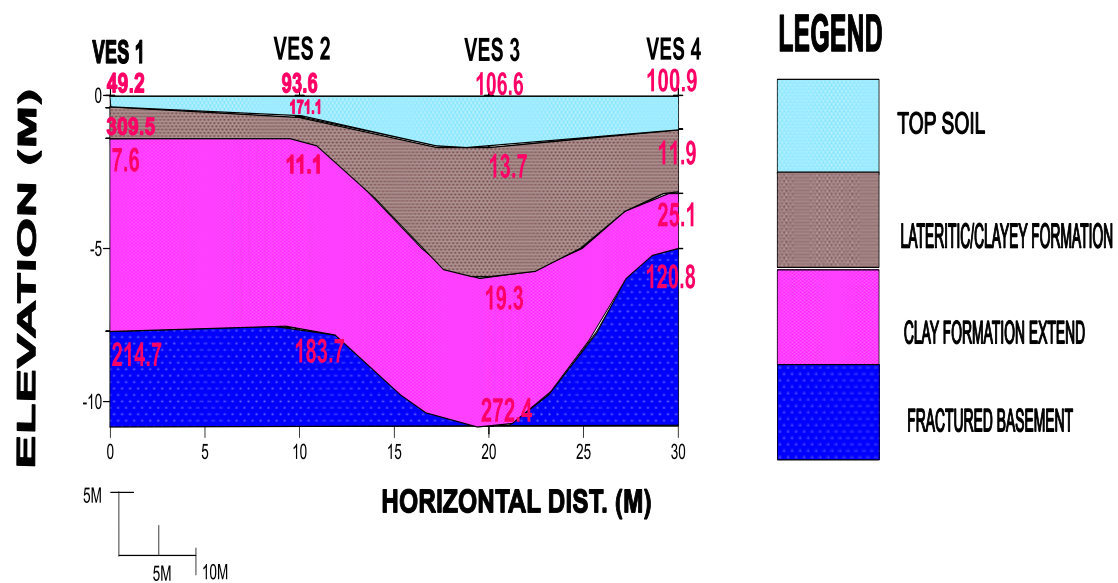
Fig 12: Geo-electric section showing resistivity values of VES1 TO VES4 traverse along Tipper Garage area

Geo-electric section of VES 1 to VES 4 along the tipper garage of stretch of the road is shown in fig. 12. Four geo-electric layers which are topsoil, lateritic clayey formation and fractured basement were delineated. The topsoil comprises clay with resistivity ranging from 49.2 to 100.9 Ωm , on this layer the overburden is thick and thickest at VES 3, the thickness ranges from 0.6 to 2.5 m. The second layer is lateritic clay formation having resistivity range of 13.7 - 300.5 Ωm , this layer is made up of clay and lateritic sand with the thickness varying from 1.3 to 6.0 m. The third geo-electric layer comprising of clay has resistivity range of 19.3 - 29.1 Ωm . The fourth layer is the fractured basement; its resistivity varies from 120.8 - 214.7 Ωm with basement depression at VES 3. Underlain by the road pavement along this stretch of the road, though not with good drainage, is the topsoil of low resistivity and this is in addition with the lack of good drainage channel may be responsible its failed state. Even with construction of good drainage channel the road may still record failure without regular maintenance.
