# Innovative Solution for Widening of Existing Highway in a Drawdown L and slide area at Hunthar Veng, Aizawal, India

**ABSTRACT** – Anthropogenic activities and natural factors have created catastrophic condition in the seismically active young Himalayan foothills. Continuous build-up of pore pressure in the slope creates decrease in intermolecular shear strength due to lubrication between these particles and rock joints. In addition, toe erosion in the valley side due to Perennial River is common in India, most of these in monsoons create destruction to the adjoining watershed areas. Similar case of the road collapse due to toe erosion in valley side generated from devastating stream and rotational failure above the road has been envisaged. Hunthar Veng area where the landslide event has been took place and the land instability problem adding on continuously due to various factors such as rainfall, earthquake, and toe erosion. Stability measures has been considered and analysed based on the severity of the problem. Structural adequacy of load bearing components has been analysed and consequently its effect and interaction with natural slope profile has been modelled using finite

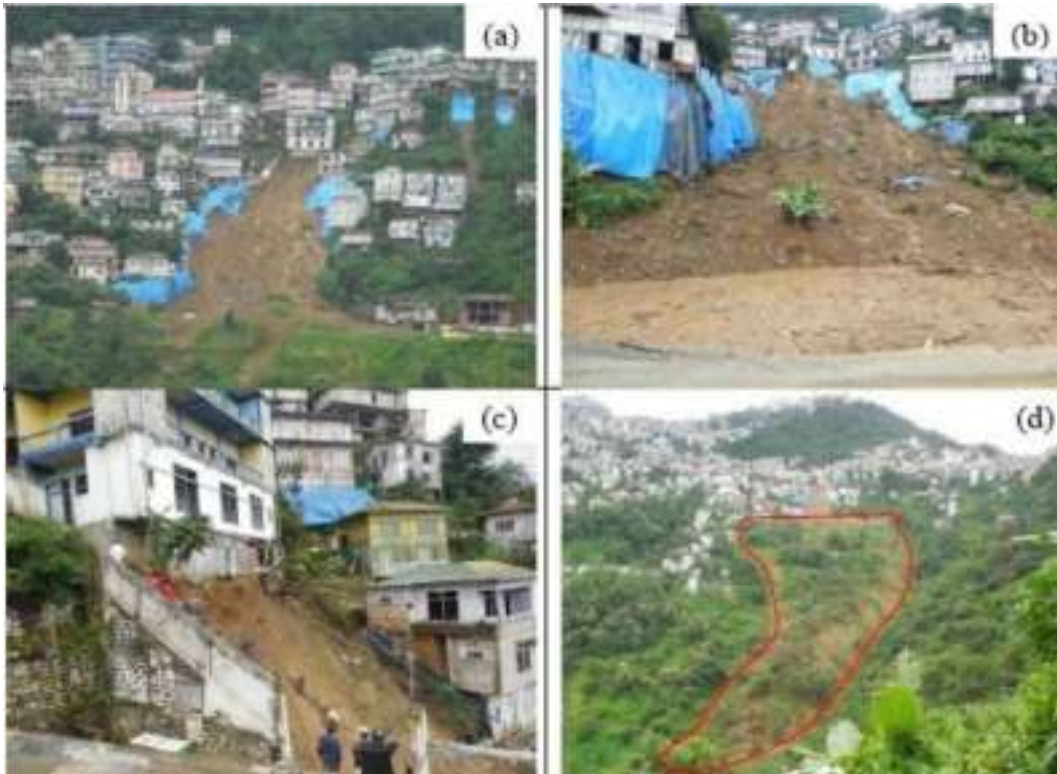
**Fig. 1:** (a) Distant view of Hunthar Venj landslide (b) Closure view of Hunthar Venj landslide (c) Main scarp of slide (d) Distant view of landslide with toe erosion due to two flowing streams at the bottom meeting a common stream.

Field investigations revealed that rocks are overlaid by about 1m to 5m slope wash material. Deep gullies are located at the site dissecting the hill slope at various locations and meeting at a common stream at the lower level in the valley side of slope. Rotational movement is observed above the road site, which is causing trouble to the

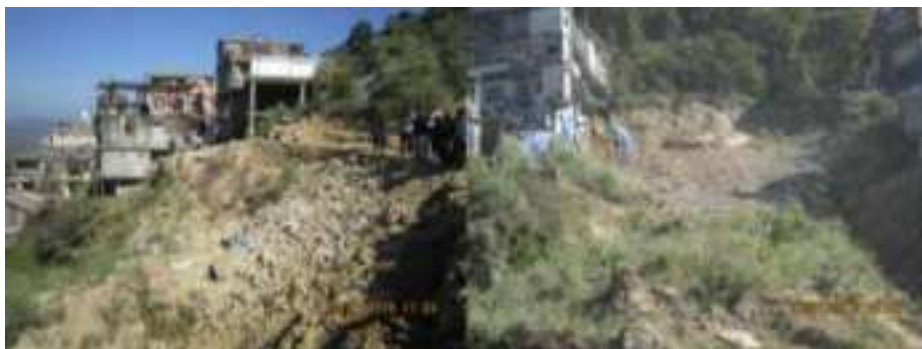
**Fig. 2:** Road collapsed due to continuous erosion at valley side

Rotational movement is creating the mass movement above the road and it continue to happen in every monsoon season. It shows that pore pressure is destabilizing force. In addition two narrow stream in the form of gullies across the slope is making slope more unstable at the upper portion of slope above the road. These streams meet at a common main stream area below the slope at valley side. During monsoon season, the main stream run to its full level and creates flood condition which ultimately scour the toe of slope end. This leads to gradual erosion of toe and at every high intensity

rain fall, flood period. This gradual erosion may lead to concentration of stresses at road level and may collapse.

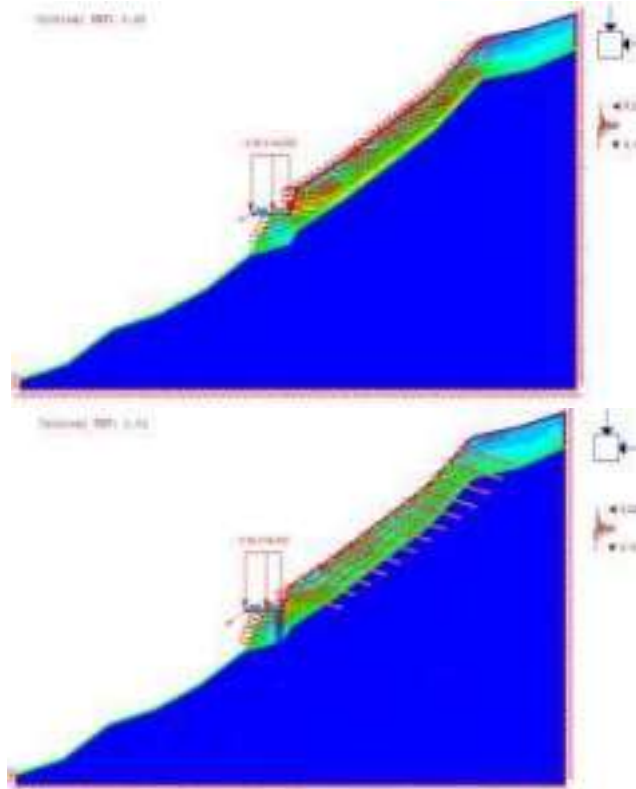
**Fig. 9:** Figure showing safety factor results before and after protection system at seismic condition

Presented case study represented the approach of modelling using structure analysis interface to check the adequacy of the integrated deck slab pile system and finite element modelling to analyse the stability of the slope. Significant improvement has been observed after removal of slope wash material below the roadway after using system of deck slab piling system. Around 88% improvement has been observed at static condition and 67% at seismic condition after using discussed protection systems.
