Long Term Landslide Mitigation Technique Illustrated case Study

Keywords: Landslide; Himalayan belt; Long term stability; Finite element modelling; Pre-stressed cable anchor; Teesta stage III hydroelectric system.

The Teesta stage III hydro project is a huge mega dam in Sikkim comprises of concrete face rock dam of 60 m height constructed across Teesta River near Chungtang village, which has seen multi-faceted impacts on the indigenous Lepcha people of Sikkim.

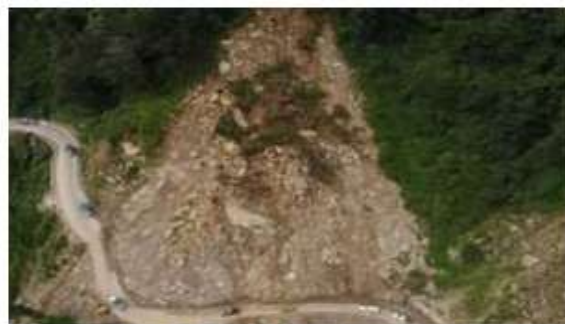
Figure 1: Typical slide zone along road

Construction of dams in seismic prone areas is a challenging task. This requires proper geological and topographical analysis in order to evaluate structural behaviour and to obtain critical safety factors. Fig. 1 depicts factor causing the reduction in the shear strength in same strata and adjoining layer. It can be seen clearly from this figure that how rain infiltrates through the persistent and non-persistent joints causing decrease in shear properties and consequently creating detachment of block in blocky rock structure and slide in highly jointed rock mass. Continuous build up of pore water pressure generates flow of muck or loose mass overlying the water resisting strata.

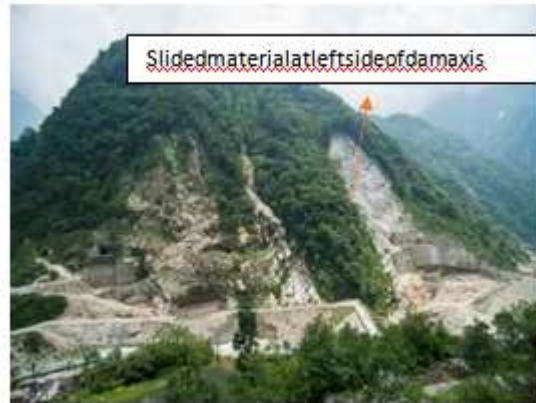
Figure 4: Protection works for unstable portion

Unstable portion was observed during construction activities at the dam site and cutting of left abutment which was susceptible to failure. GSI of 25 shows the rock structure of disintegrated-poorly interlocked, heavily broken rock mass with mixture of angular and rounded rock pieces. This value of GSI suggests a weak rock condition.

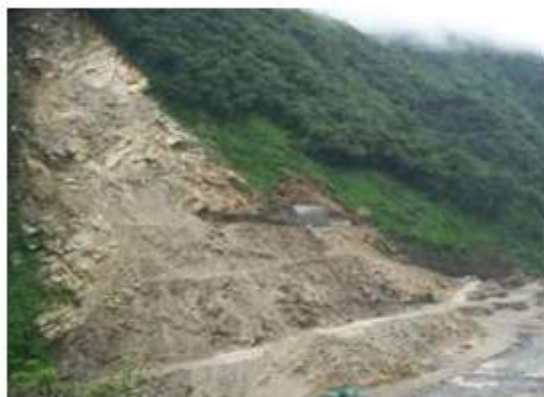
Figure 5: Site condition before start of work

rock formation of central crystalline; subdivided into Chungthang series, Darjeeling gneiss & Rongli series of Pre-Cambrian age. Chungthang series comprises of quartz, biotite gneiss, biotite schist, calc-silicate and thinner bands of argentiferous – sillimanite heavily micaceous gneissose. Rock units are highly folded; asymmetric, isoclinal in nature with NE dips. Landslide issue was observed due to excessive stripping and cutting of the left abutment as shown in fig. 5. About 1 lac m³ debris slid down the hill after the cutting work at left abutment of dam site.

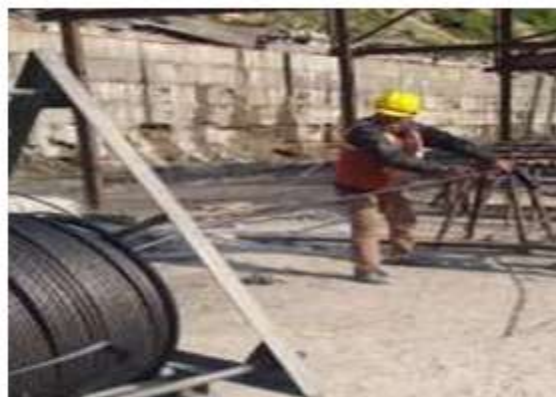
Figure 6: Before commencement of cable anchoring

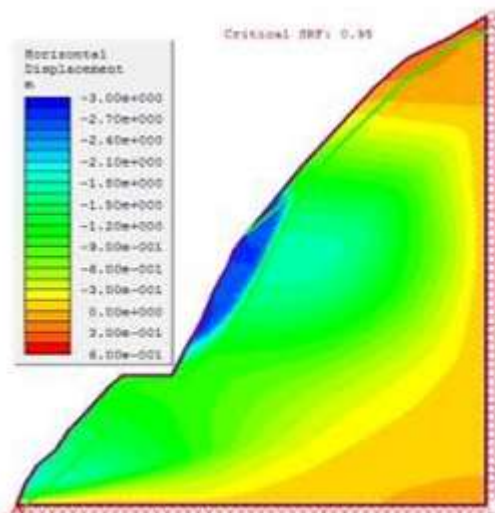
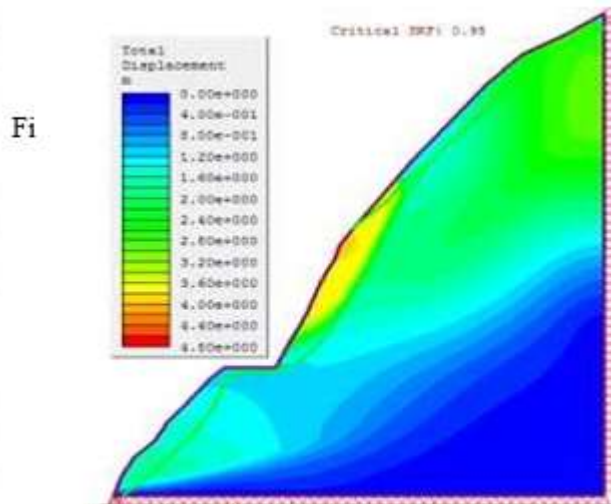
Analysis of left abutment at dam axis shows that the slope is quite unstable under static and seismic condition with SRF 0.95 and 0.81.

Figure 10. (a) Horizontal displacement

Figure 10. (b): Total displacement for unstable slope under static condition

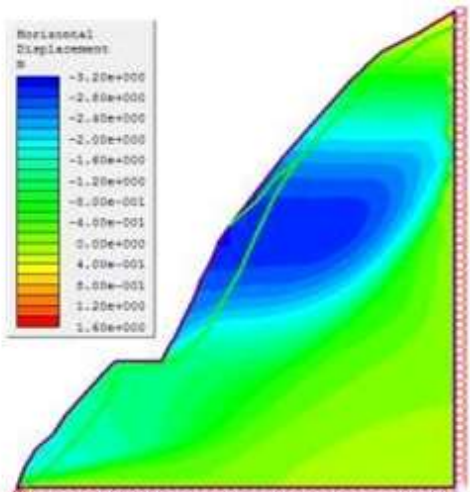
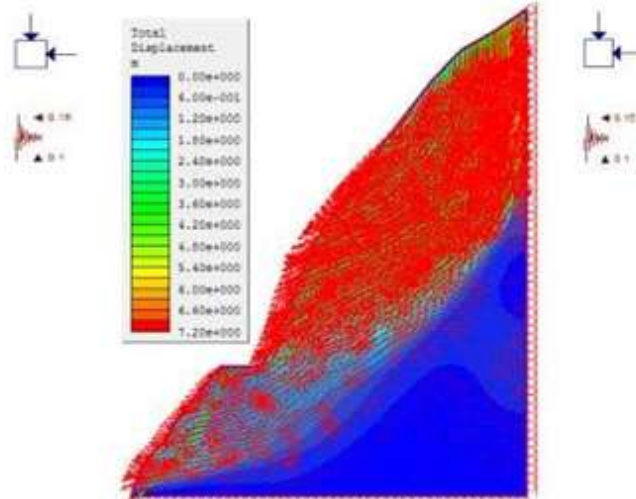
Figure 11. (a) Horizontal displacement seismic condition

Figure 11. (b) Total displacement for unstable slope under seismic condition

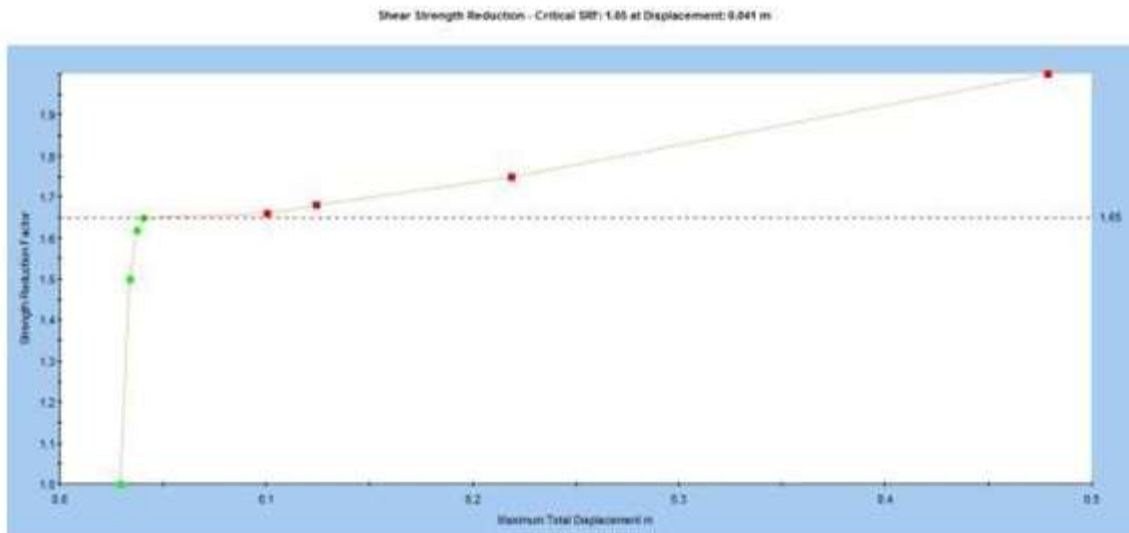
Figure 13. Variation of strength reduction factor with maximum total displacement for static case (with stabilization)

Following results depicts effect of inclusion of pre-stressed cable anchors in reducing horizontal displacement, total displacement. Critical SRF value of 1.65 with 41 mm displacement for

the static case (fig. 10 to 14) and 1.32 critical SRF with 47 mm displacement has been observed under seismic case (fig. 15 to 17).

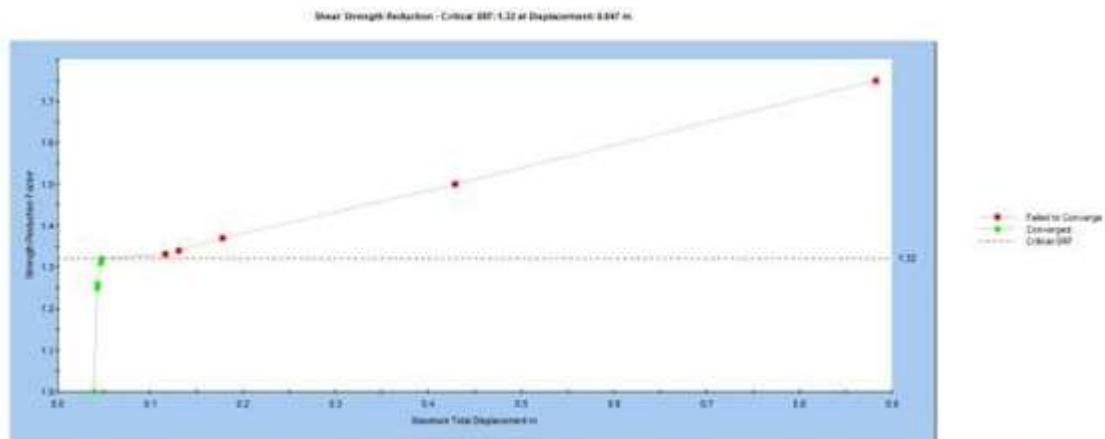
Figure 15. Variation of strength reduction factor with maximum total displacement for seismic case (with stabilization)

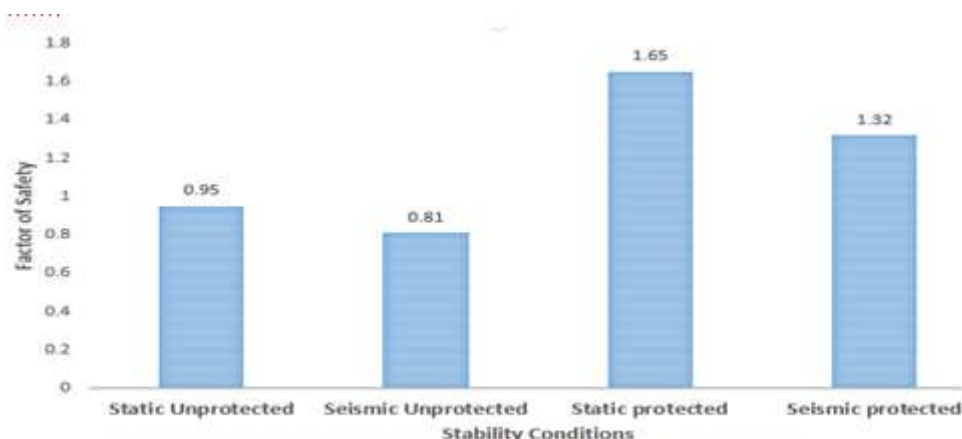
The chart shows the relative increase in critical SRF values for stabilized and unstabilized conditions under static and seismic case.

Figure 16. Variation of strength reduction factor under different stability conditions

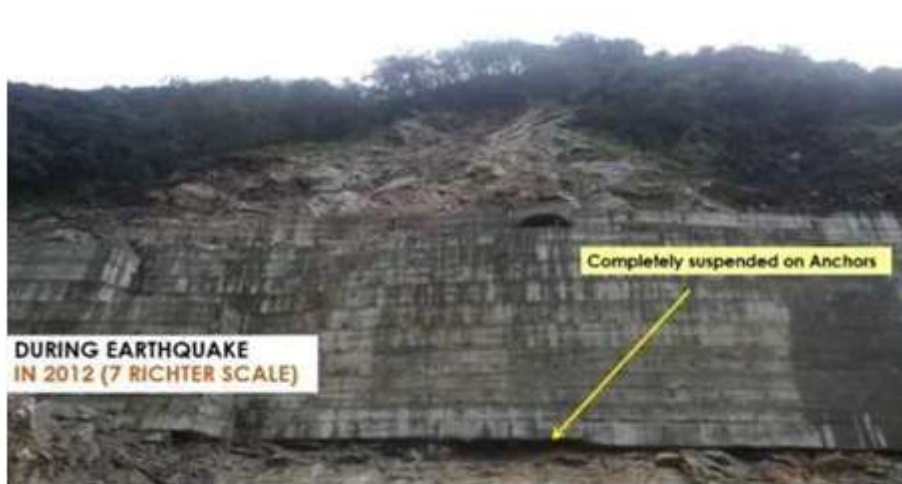
Figure 17: Condition of stabilized slope with pre-stressed anchor after 2012, earthquake (Magnitude 7)

Present analysis shows that there is significant improvement in the safety factor results. The current status of the project site is that the 50m vertical cladding wall having pre-stressed cable anchor with no base support survived the 2012 earthquake of 7 Richter magnitude scale with no signs of distress.
