# Evaluating the Effects of Development Traffic towards Achieving Sustainable Road Network in Nigeria

<sup>1,2,4,5</sup>Department of Civil Engineering Technology, Federal Polytechnic Nasarawa, Nigeria

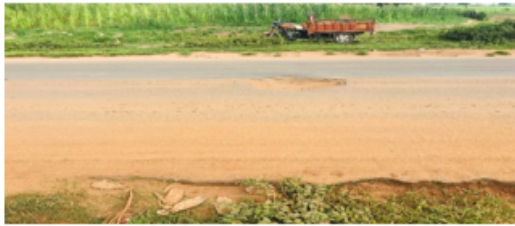
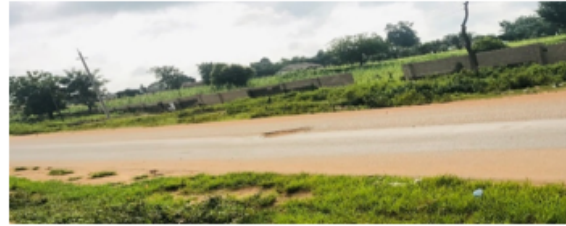
Fig 1: Some Distresses Located at about 1.03 km from the Origin (Low-cost Junction)

1. Surface distress: this is an indication of poor or unfavorable performance of the pavement. This is seen as a form of roughness, raveling, cracking; which allows moisture infiltration into the base and subgrade, eventually resulting into pothole as seen.

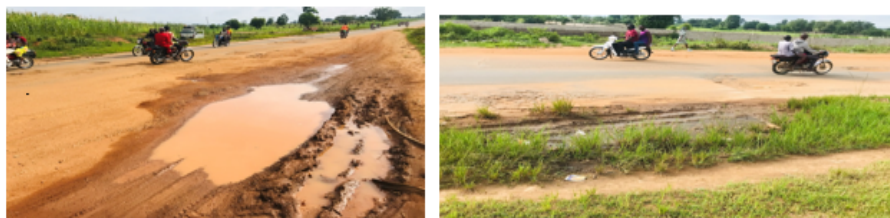
Fig 5: Some Effects of Lack of Drainages at about 31 km from the Origin

- 2.
3. There is nodrainage: there is obstruction in the natural drainage along the section of the road which impedes the flow of water. This can cause failure of the pavement as water may tend to pass through the pavement

- i. Adequate and standard drainages and culverts should be provided and the formation levels be appreciably raised in all the problem areas.
- ii. The shoulders should be reconstructed as they are virtually non-existent in most areas along the stretch of the road.

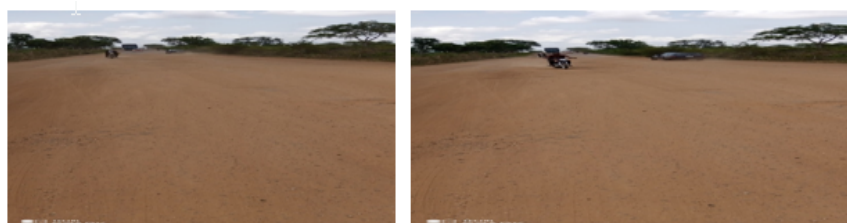
Fig 6: Some of the Many Areas with Erased Pavement Markings (within about 1-13km from origin)

4. Absence of Pavement markings: due to lack of maintenance: the road markings were wiped off either by the effect of vehicular wheels or climate condition.

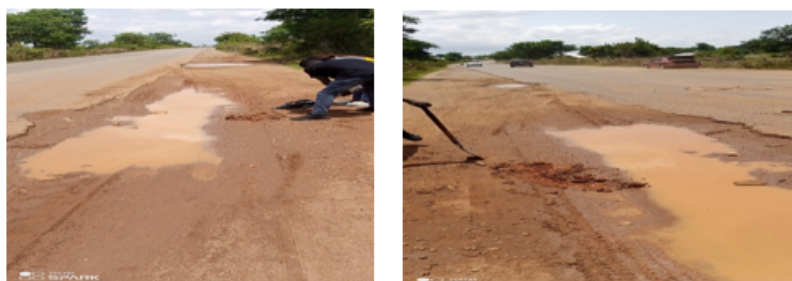
Fig 7: Some of the Many Scraped Shoulders (within 20-31km from origin)

5. Absence of Shoulders: due to absence of shoulder the water that flows off the natural drainage tends to settle by the pavement side which penetrates into the base and subgrade and may lead to pavement failure.

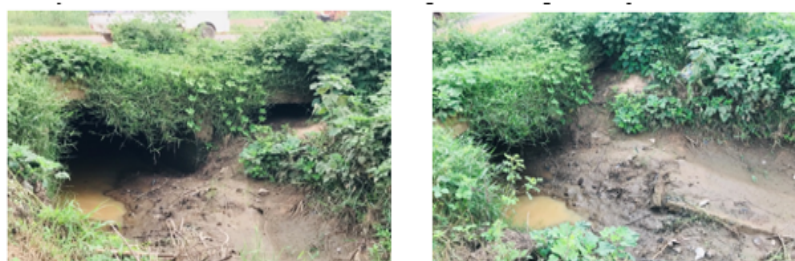
Fig 8 : Some of the few Blocked Culverts (located at about 2.1 and 13.5 km from origin respectively)

6. Blockage of culvert: obstruction in the flow of water which tend to hinder the directional flow of water. This may lead to infiltration of water into the base or subgrade which might lead to pavement failure

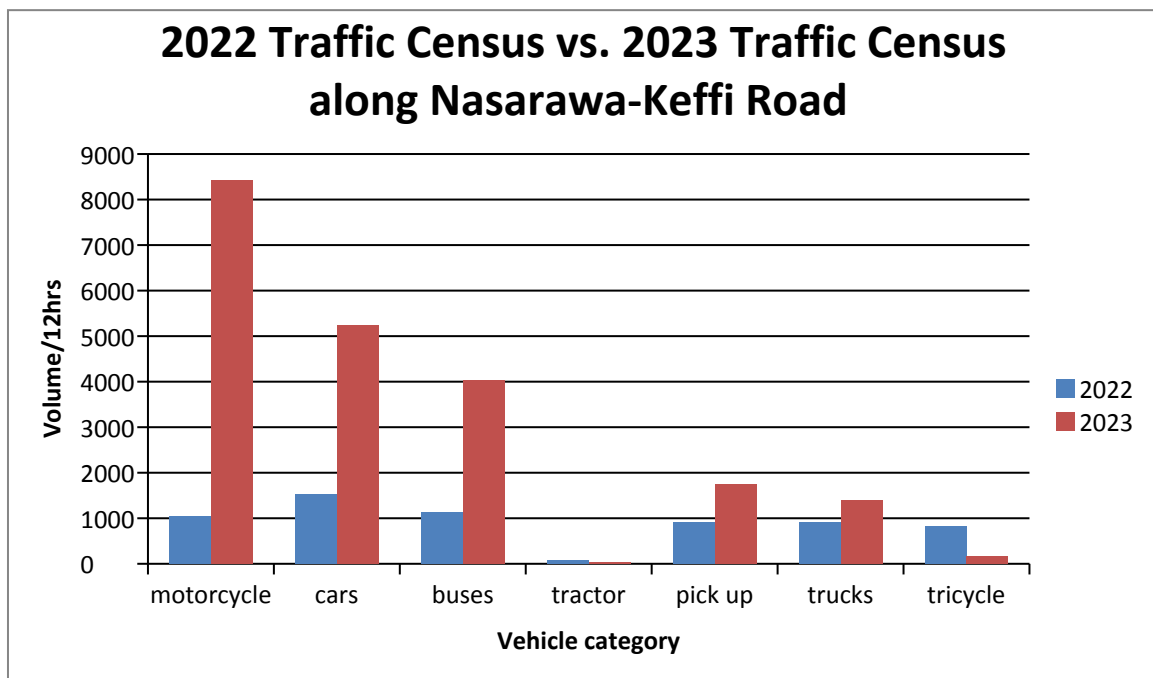
Fig 8: 2022 Traffic Census vs. 2023 Traffic Census along Nasarawa-Keffi Road

- The total traffic volume/day for May 2022 = 6410 vehicles/day.
- The total traffic volume/day for May 2023=19450 vehicles/day.

Percentage change (% in traffic (from 2022-2023))  
= = 213.46% increase in traffic between 2022 and 2023.

- vi. Also because of very high traffic increase rate of about 214% from 2022 to 2023, there should be need for expansion of the road.
- vii. The entire contract, design, construction, maintenance and operation plans should be guided by the most modern (state of the art) approaches as can be obtained in advanced countries from some parts of Europe and Asia.
