Geophysical Investigation of Road Pavement Instability: A Case Study of Moshood Abiola Polytechnic (Mapoly) – Onikolobo Road, South Western Nigeria

ABSTRACT

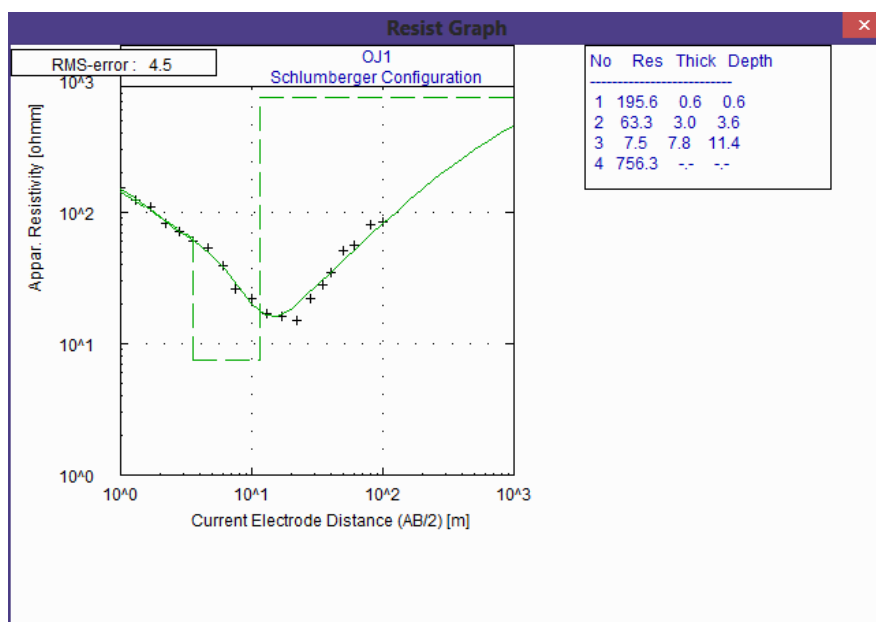
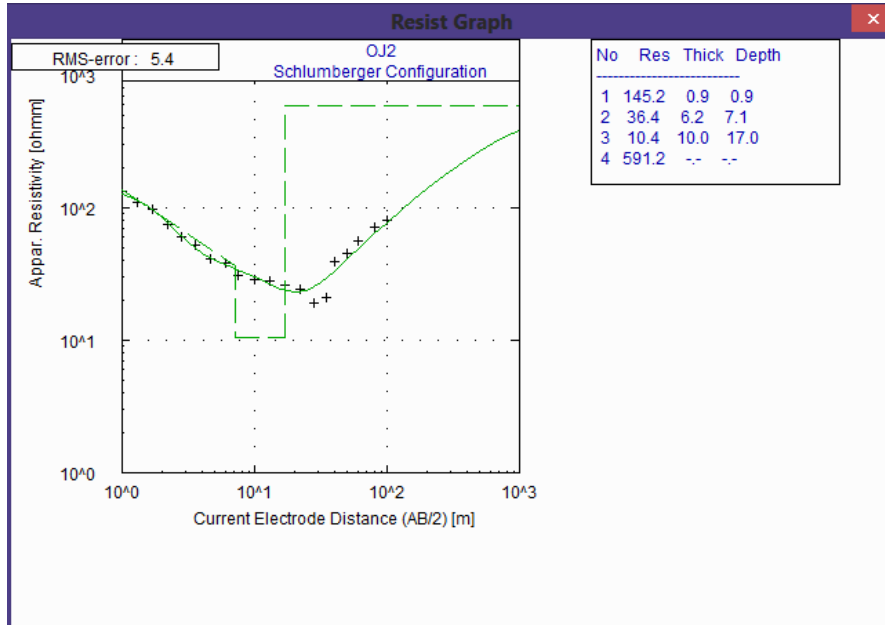
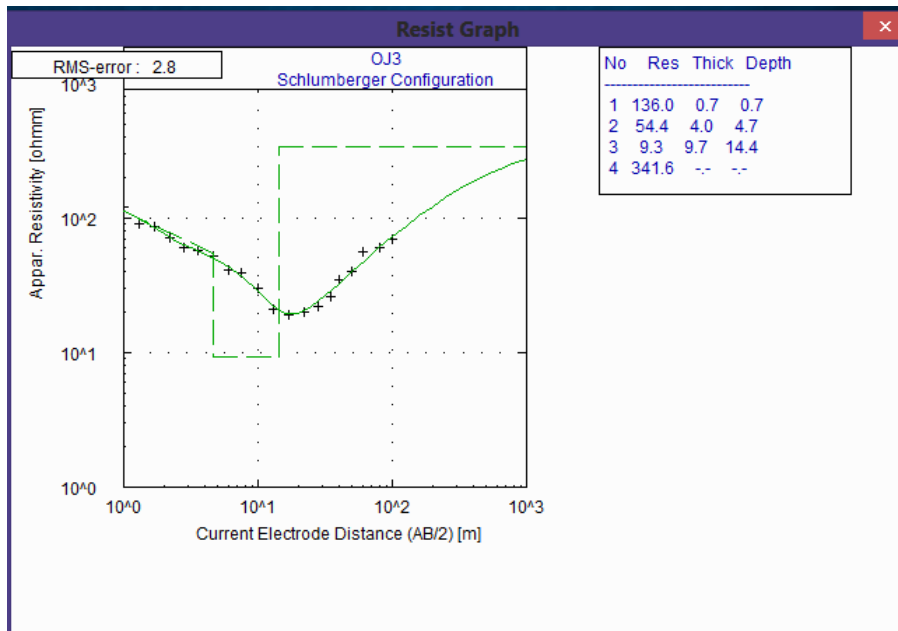
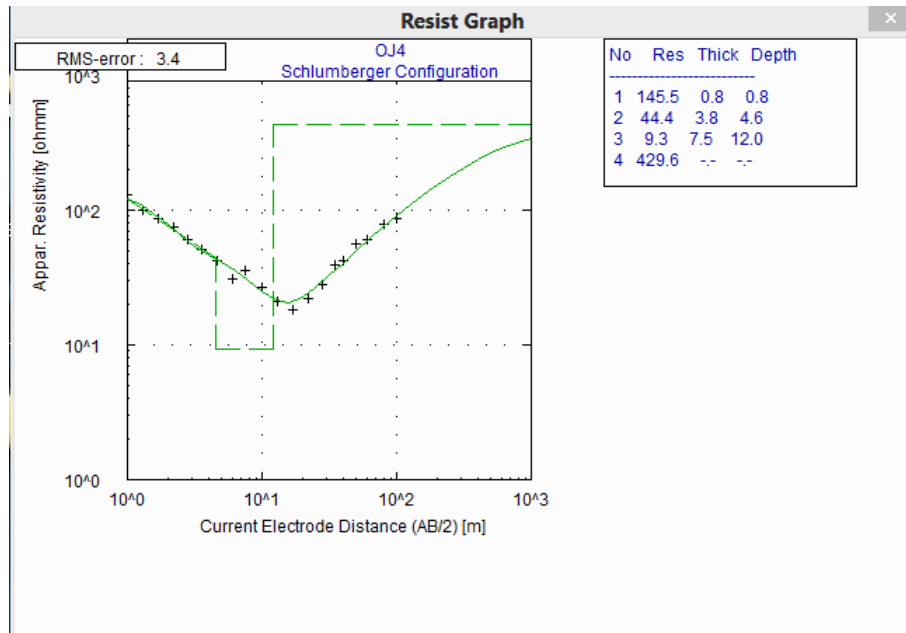
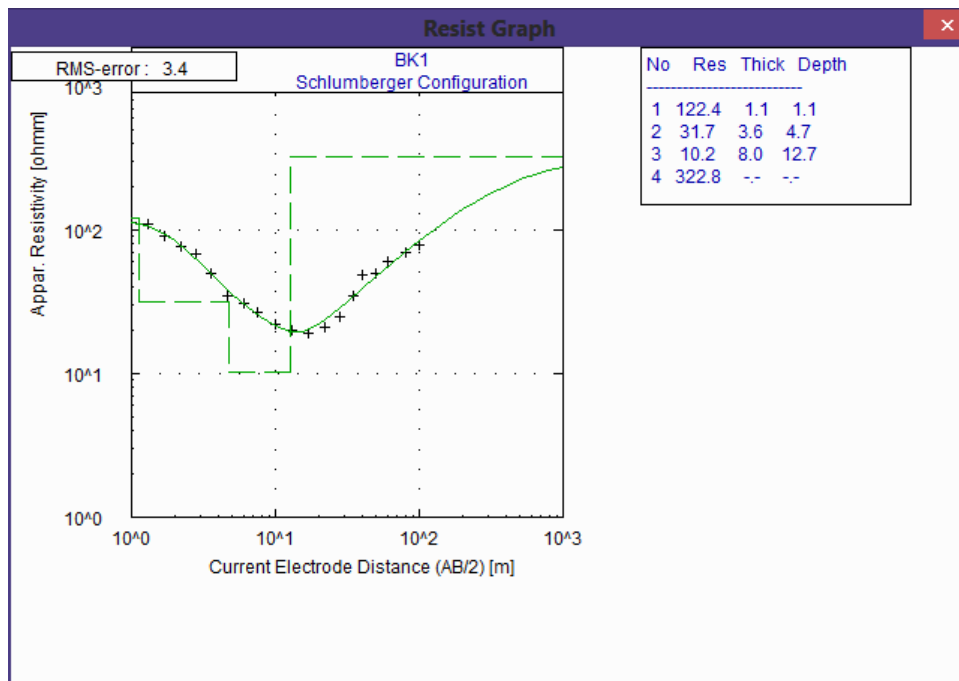
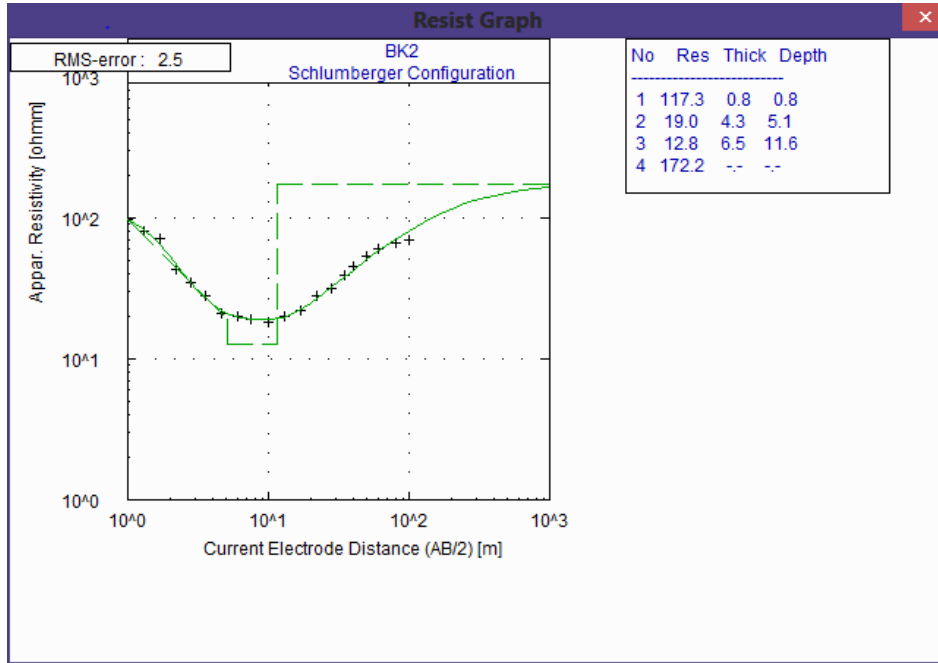
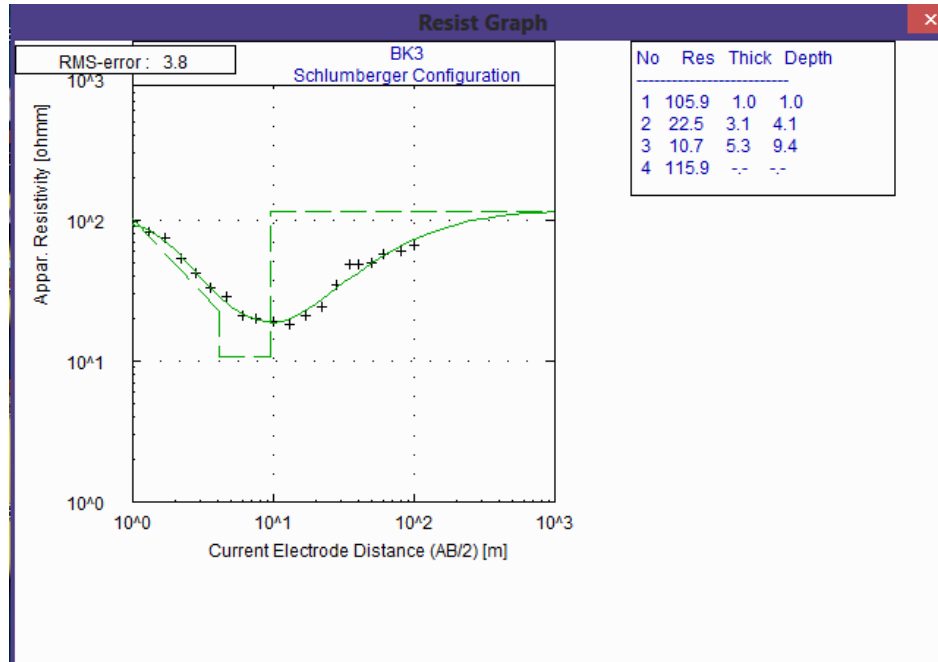
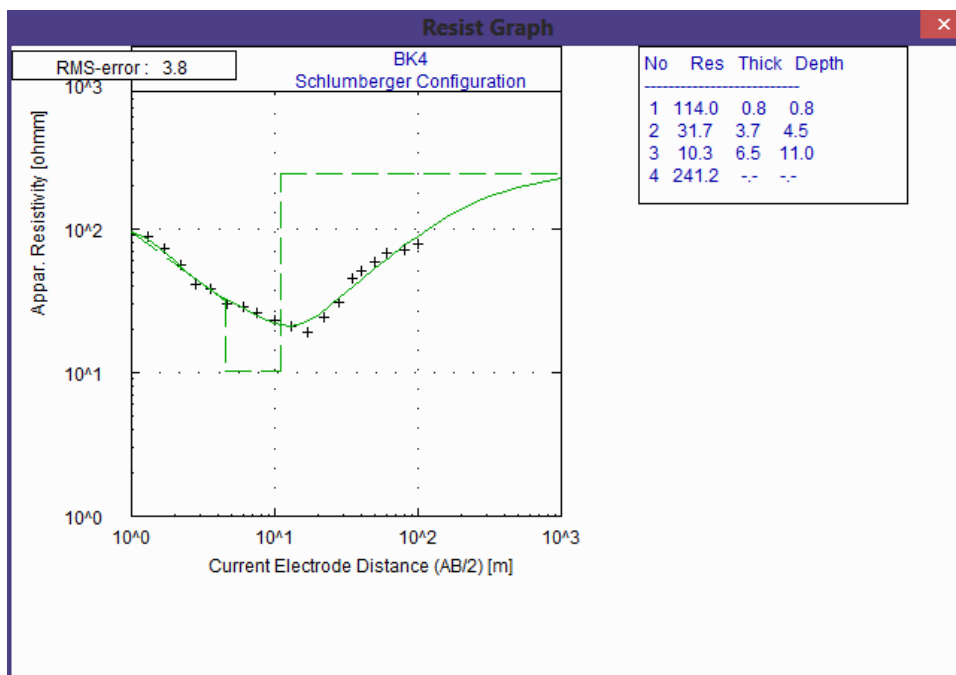
Fig.1: Sounding curve obtained from VES1 (OJ1) along Ojere part of the road

Fig.2: Sounding curve obtained from VES2 (OJ2) along Ojere part of the road

Fig.3: Sounding curve obtained from VES3 (OJ3) along Ojere part of the road

Fig.4: Sounding curve obtained from VES4 (OJ4) along Ojere part of the road

Fig.5: Sounding curve obtained from VES1 (BK1) along Bank area of the road

Fig.6: Sounding curve obtained from VES2 (BK2) along Bank area of the road

Fig.7: Sounding curve obtained from VES3 (BK3) along Bank area of the road

Fig.8: Sounding curve obtained from VES4 (BK4) along Bank area of the road

From the vertical electrical sounding (Fig 1 to 8), four types of sounding curve have been obtained, they include QH, K, A and HA types. In all, the number of layers delineated ranges from 3 to 4. For QH curve, $\rho_1 > \rho_2 > \rho_3 < \rho_4$, for K curve, $\rho_1 < \rho_2 > \rho_3$, for A curve, $\rho_1 < \rho_2 < \rho_3$ and for HA curve, $\rho_1 > \rho_2 < \rho_3 < \rho_4$. The Geo – electric sections were then produced from this series of results of vertical electrical sounding.

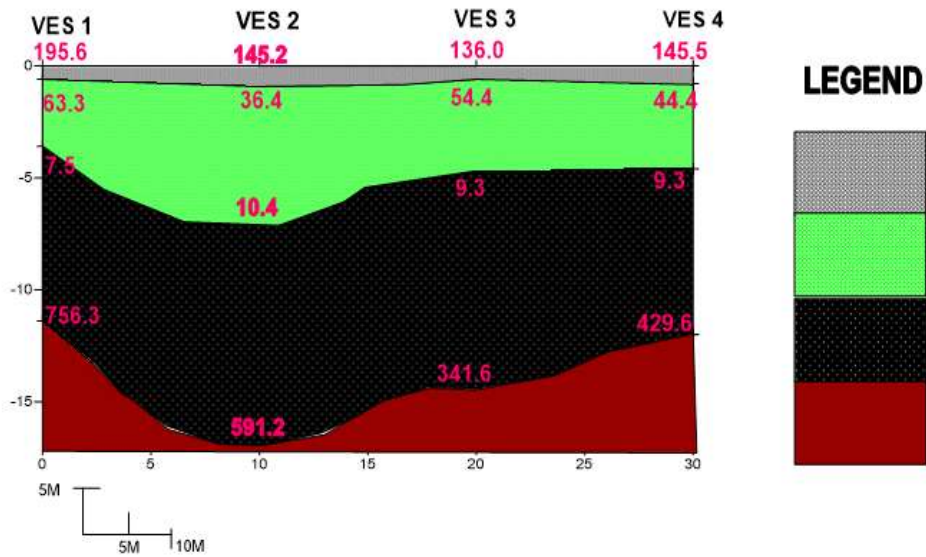
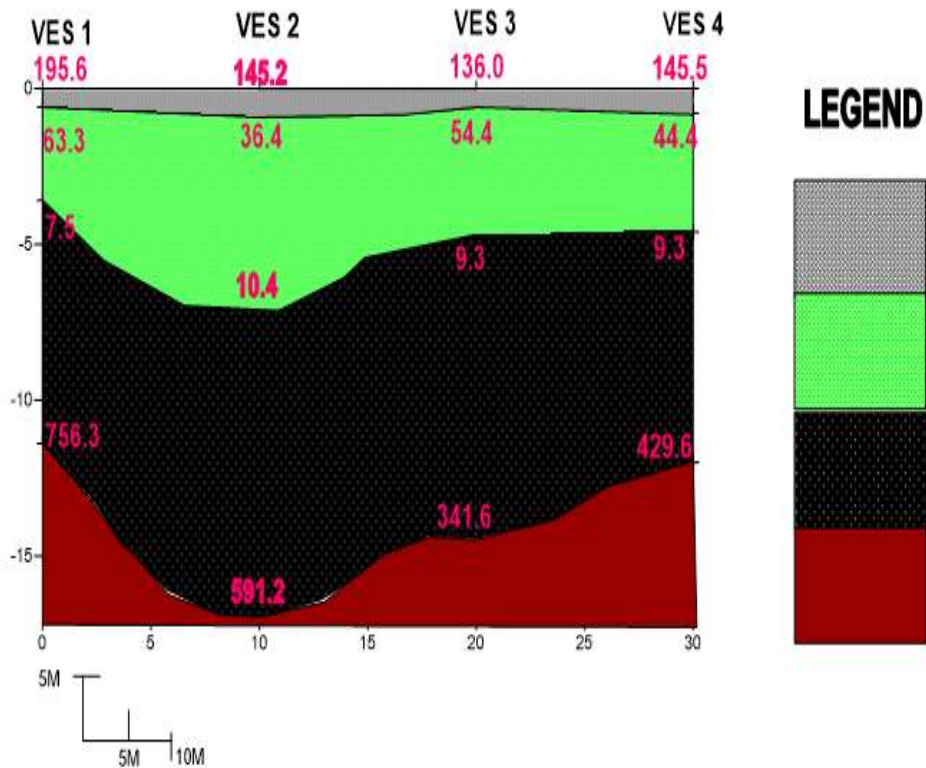
Fig 9: Geo-electric section showing resistivity values of VES1 TO VES4 traverse along Ojere village area

Fig. 9 represents the geoelectric section obtained from the VES along Ojere village area of the road. This geo-electric section shows the spatial

distribution of each layer of the subsurface.. The section shows four distinct layers which include the top soil, the lateritic soil, the weathered basement and the fracture basement respectively from top to bottom. The topsoil comprises sand/lateritic sand whose resistivity ranges from 136.0 Ωm to 196.6 Ωm, the thickness of this layer varies along the traverse and less than 1 m, it is thickest at VES 2, about 0.9 m. the average thickness along this layer is 0.75 m. The second layer is the lateritic medium to silty grained sandstone having a resistivity range of 36.4 to 63.3 Ωm with an average thickness of 4.25 m, it is thickest at VES 2 with a thickness of 6.2 m. Weathered basement is the third layer with resistivity range of 7.5 to 16.4 Ωm. The third layer,

the weathered basement has a resistivity range of 7.5 to 10.4 Ωm . This low value of resistivity as a result of highly weathered disaggregated minerals which are essentially clay. The fourth layer being the fresh fractured basement has a resistivity range of 341.6 to 756.3 Ωm . The overburden is thickest at VES 2 and a gentle depression is noticed at VES 2. The portion of the road, Ojere village, area where these VES 1 to VES 4 lies is in a serious failed state and this is due to clay composition of the underlying layers of low resistivity values which is characteristics of clay minerals. The basement depression under VES 2 might also have contributed to the failed state of this portion of the road.
